³ NANTICOKE RIVER BASIN
LITTLE CREEK, SUSSEX COUNTY
DELAWARE

² HORSEYS POND DAM

DE 00022

¹ PHASE 1 INSPECTION REPORT
NATIONAL DAM SAFETY PROGRAM.

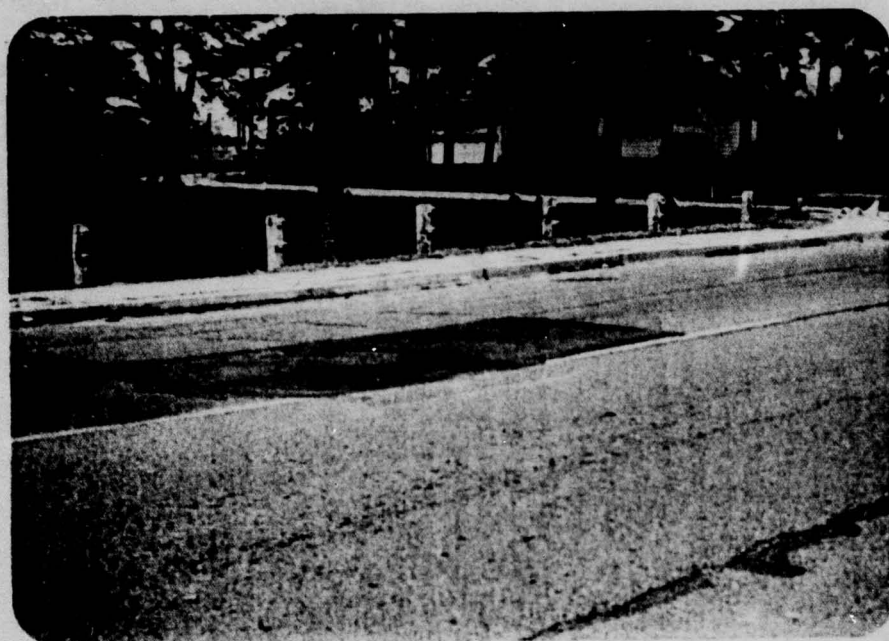
PHOTO 7 - View of house located on downstream embankment
